Report on 30th October, 2020 earthquake in Turkey

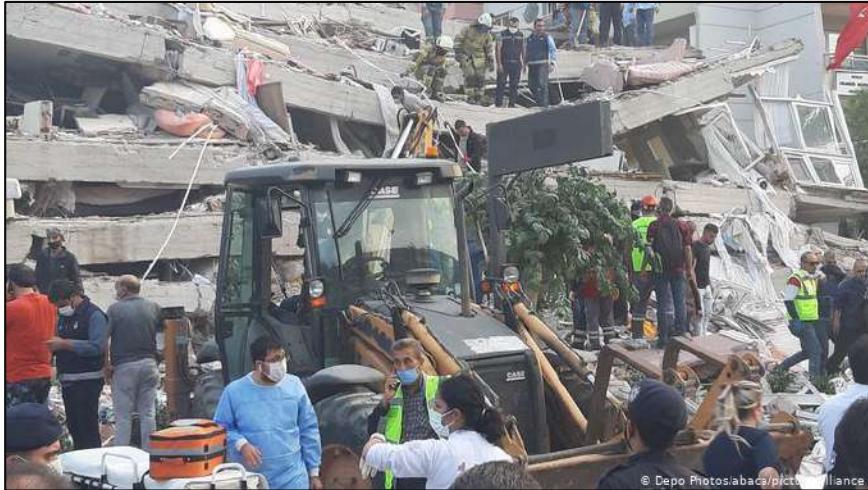
Figure: Collapse of a building

techniques like base isolation to prepare for the natural disasters. In base isolation, the floor of a building is separated from its foundation, connected by strong but flexible isolators that allow the ground to shift underneath while the building wobbles above. But Izmir has many older buildings that aren't equipped for quakes, the (Times, Oct. 31, 2020) reports.

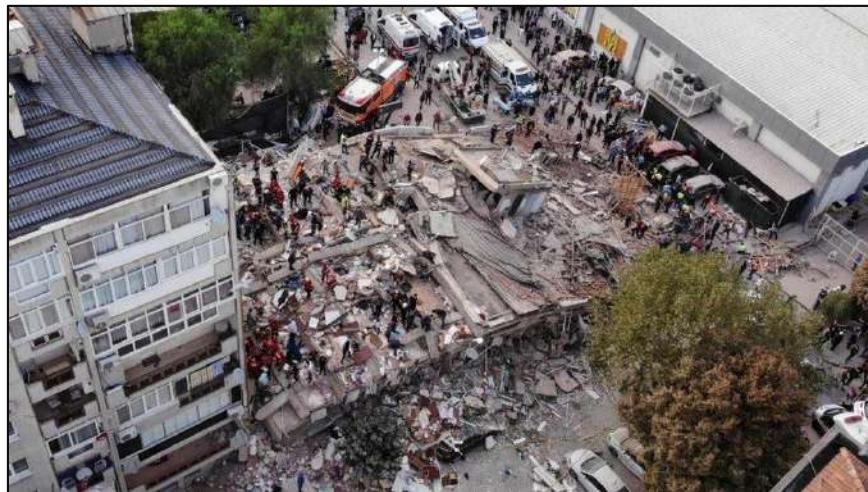
Figure: Vertically damage of a building

What cause building Collapse (TEMBLOR, 2020): At that time in Turkey, 4% of the city’s buildings were affected — six collapsing completely. The cause for these losses appears to stem from three elements: strong amplification of shaking throughout the basin in which Izmir sits, poor code compliance and inadequate construction inspections that prevailed in the 1990’s when many of these heavily damaged and collapsed buildings were constructed.

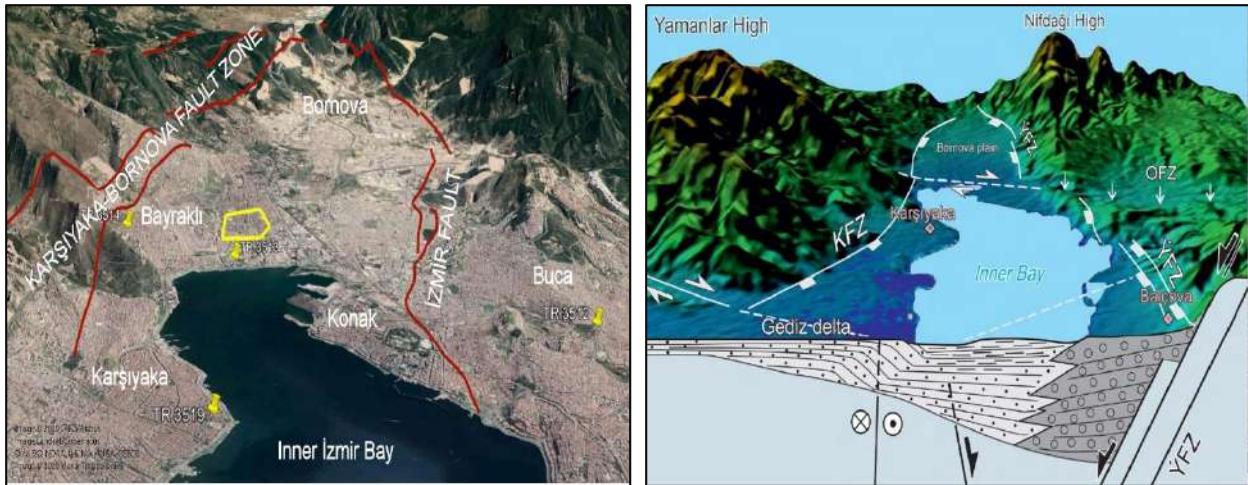
Figure: Izmir city morphology

The city of Izmir is located around the Inner Izmir Bay. Inner Izmir Bay is an actively growing shallow marine basin controlled by active E-W trending extensional ('normal') faults in the Aegean Extensional Province. The young (Holocene) alluvium and fan-delta to shallow marine deposits, confined and controlled by the Izmir Fault to the south and the Karşıyaka-Bornova fault to the north, constitute the uppermost sediments in the basin. The fault lines indicated on Figures 1 and 3 are taken from the fault maps prepared by the General Directorate of Mineral Research and Exploration. The soft sediments and basin structure itself played a large role in amplifying the shaking.

a. Izmir is built on very soft, young sediments that amplified shaking

The expected amplification of seismic shaking is generally inferred by the average seismic shear wave velocity in the upper 30 m ('Vs30'). A Vs30 map of the Inner İzmir Bay Basin is provided in, after İzmir Earthquake Masterplan. Most of the heavily built areas are located on the soft sediments of the city located in Karşıyaka, Bayraklı, Bornova and Konak districts. The distribution of Vs30 (average shear wave velocity in the upper 30m) map of the Inner İzmir Bay Basin (after İzmir Earthquake Masterplan). The polygon enclosing the collapsed building in Figures 1 and 3 lies in the red zone of highest amplification of the seismic waves. (Jazeera, 2020)
